CONNECTICUT RIVER BASIN
WEST HARTFORD, CONNECTICUT

BUGBEE RESERVOIR DAM CT 00491

PHASE I INSPECTION REPORT NATIONAL DAM INSPECTION PROGRAM

JUNE 1981

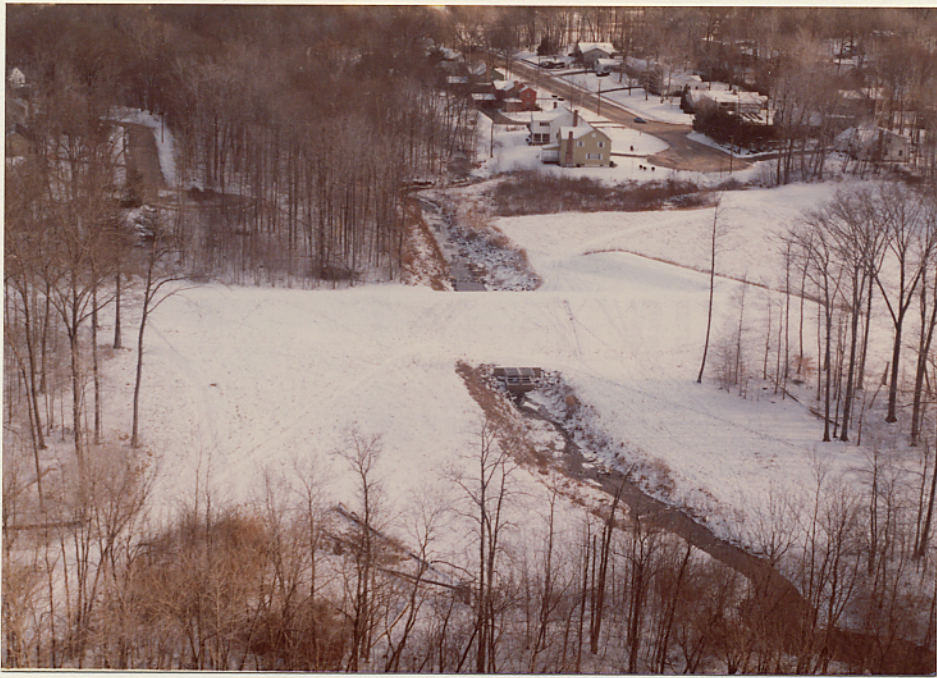
The dam is a grass covered, earthfill embankment with a foundation drain trench underlying the downstream slope. As shown in Photos 1 and 2, the alignment appeared good with no signs of vertical or horizontal movement. There was no evidence of any erosion on the dam embankment which was covered with a two to three inch layer of snow. Minor rutting was observed along the crest of the dam indicating some vehicular trespassing.

Photo 1 - View looking east along
the upstream side of the
dam embankment

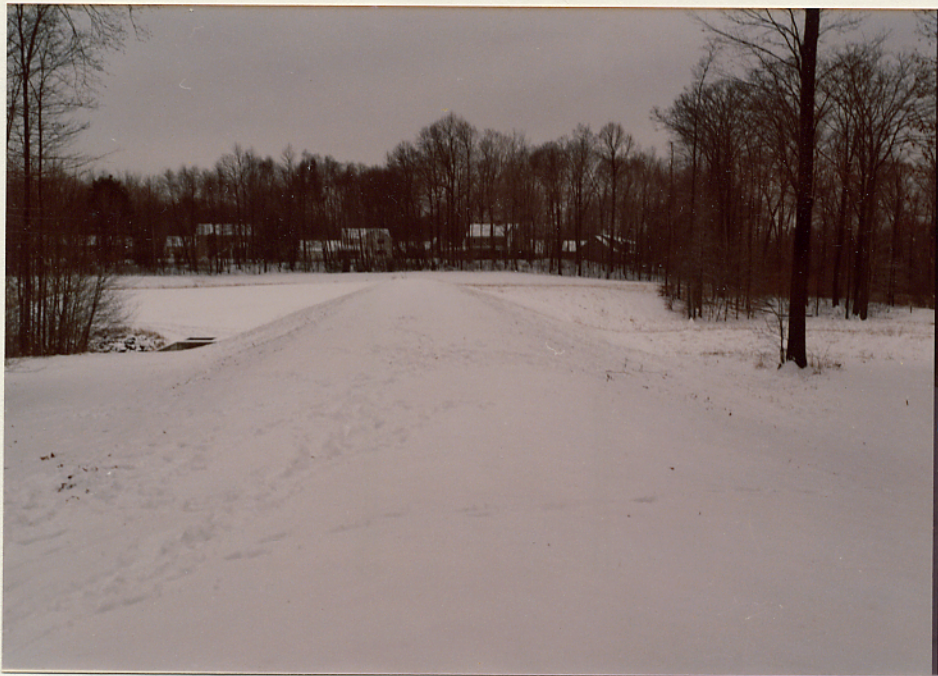
Photo 2 - View looking south along the
top of the dam embankment

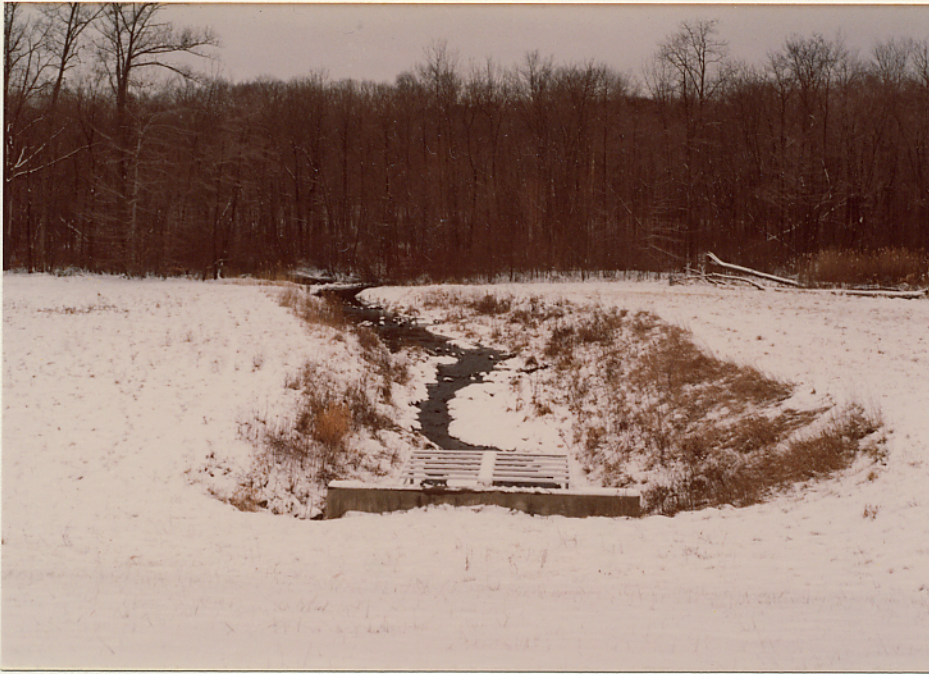
The principal spillway consists of a two stage reinforced concrete intake riser with a 48" reinforced concrete pipe and a reinforced concrete impact basin. Impounded storm-water runoff and the normal brook flow passes through the dam embankment in these structures. The general condition of the structures was very good with no evidence of any concrete cracking or spalling (See Photos 4 & 5). Located at both the high level and low level inlets of the intake riser, the metal trash racks were well painted and structurally sound. The metal safety mesh cover on top of the impact basin was moderately rusted and showed signs of minor deterioration. Observations revealed a small pile of rip-rap in front of the trash rack at the low level inlet of the intake riser partially obstructing the brook flow. The channel upstream from the riser was clean and in good condition as shown, in Photo 3.

Photo 3 - Upstream channel

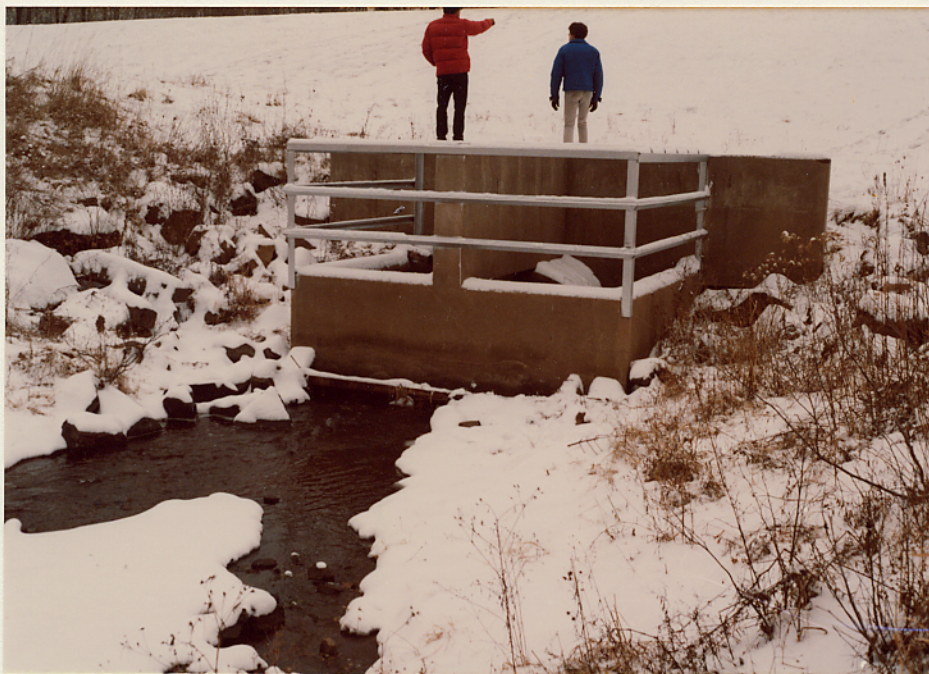
Photo 4 - Principal Spillway -
Intake Riser

3. A comprehensive program of inspection by a registered professional engineer qualified in dam inspection should be instituted on a biennial basis.
4. Remove the pile of rip-rap situated in front of the trash rack at the low level inlet at the intake riser.
5. Repair and paint metal safety mesh cover on top of the impact basin.

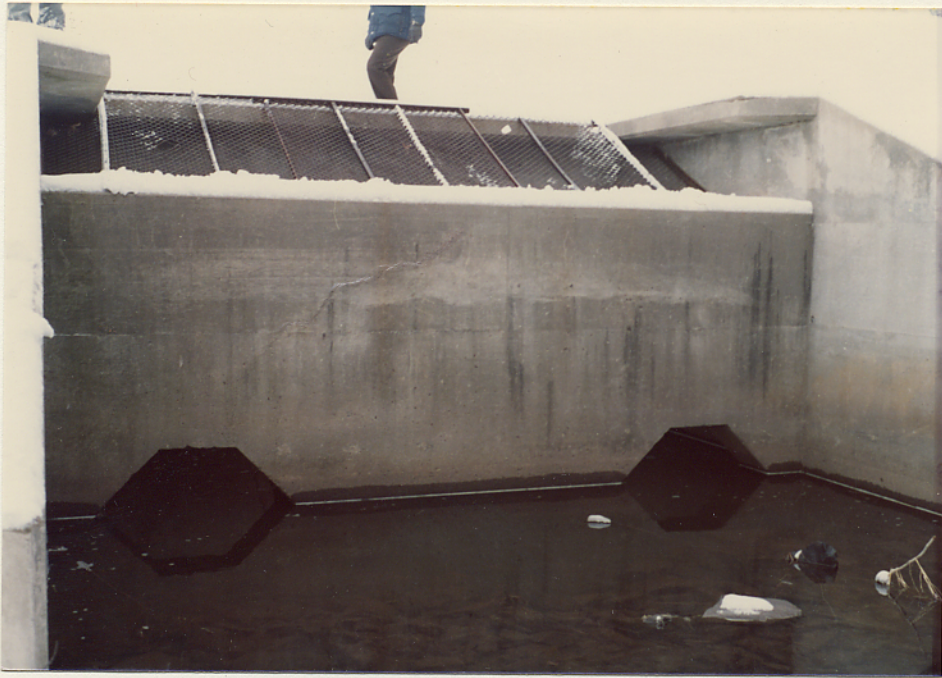
No evidence of any downstream embankment seepage was observed; however, since the reservoir area was dry, no conclusive determination could be made. The foundation underdrain system discharges into the mesh-covered impact basin which prevents close inspection of the two drain outlets. Observations made from the top of the impact basin indicated the outlets to be clean and dry.

Photo 5 - Principal Spillway
Impact Basin

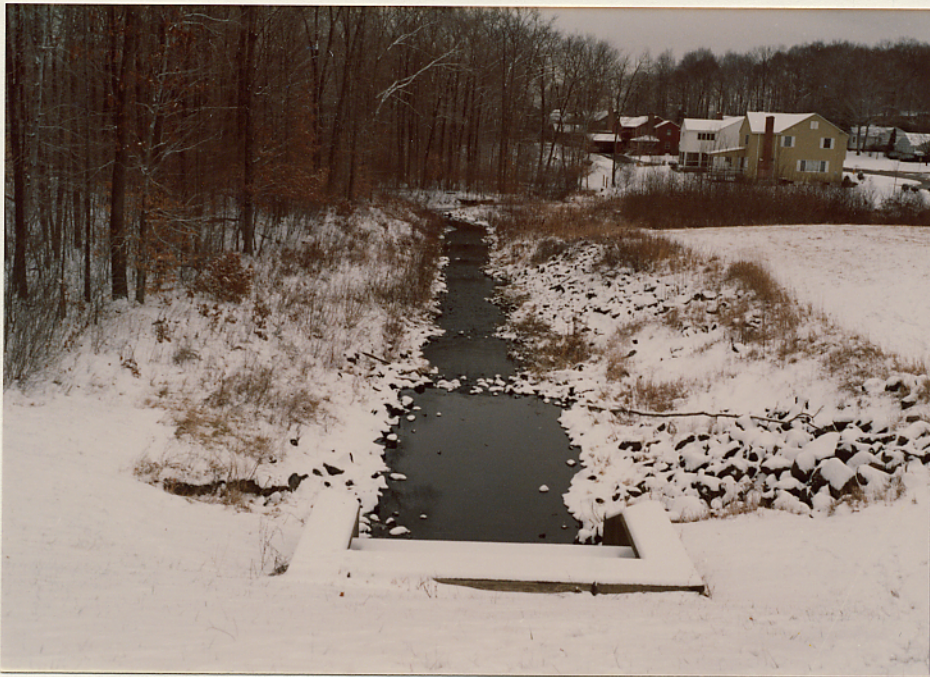
The channel downstream from the principal spillway is rocky and generally in very good condition as shown by Photo 6. Minor brush growth was noted along the channel slopes which appeared to be stable. The rip-rapped area just downstream from the impact basin was also stable with no evidence of failure.

Photo 6 - Downstream channel

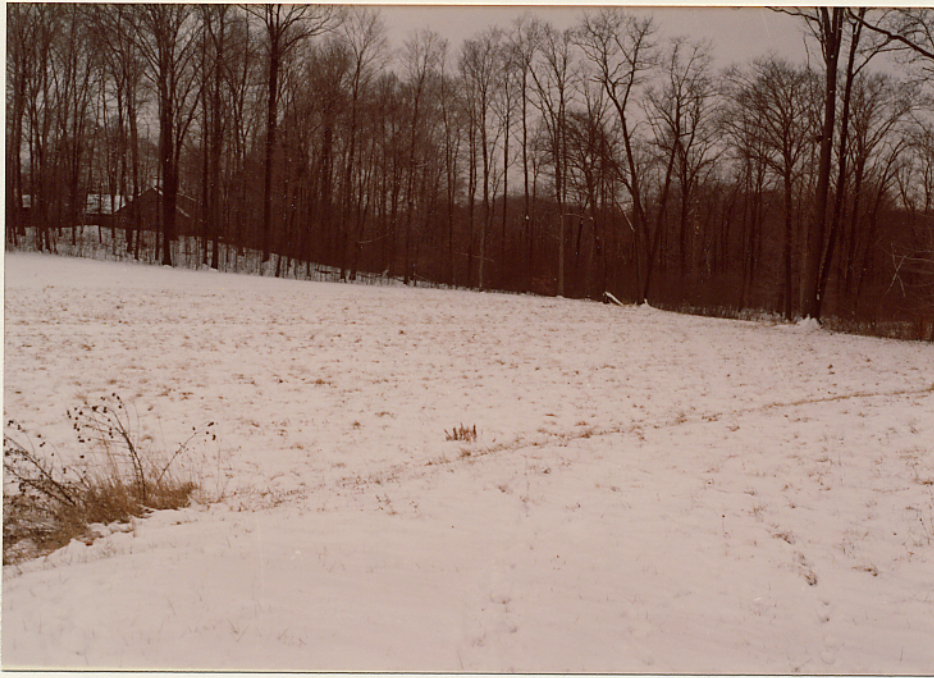
Located at the south end of the dam, the emergency spillway which was covered with a two to three inch layer of snow appeared to be in good condition (See Photos 7 & 8). There was no evidence of any vehicular trespassing or erosion along the channel floor or slopes. The earthfill dike situated on the north side of the spillway appeared stable as was the rip-rapped slope along the south face of the dike.

Photo 7 - View of inlet end of
the emergency spillway

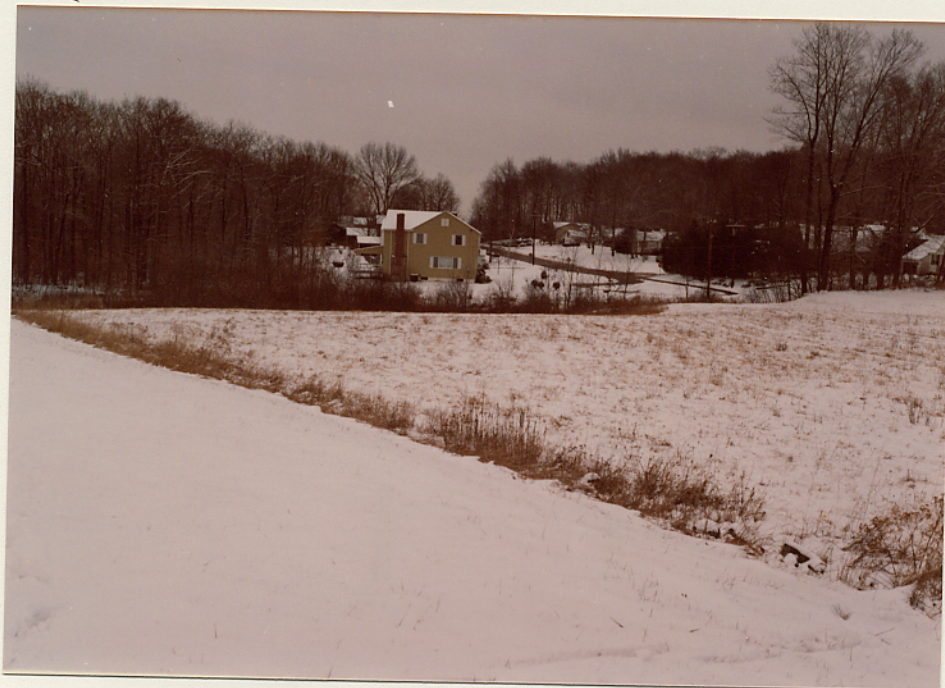
Photo 8 - View of outlet end of
the emergency spillway
